Harriet Lewars & Jonida Mecani

Conserving a pietre dure table

This joint paper will present the ongoing conservation of an eighteenth century Italian pietre dure table. The table top and base are being treated separately by the two authors. The object, privately owned, is one of two matching rectangular pier tables which had deteriorated after thirty years of being kept in a household conservatory. Unfortunately the unstable environment had actuated some difficult conservation problems; for the base this included structural splits, instability and surface losses, whilst for the table top, a total cohesive failure between individual decorative stones and ground layers, further complicated by extensive losses, fracturing and previous restorations. We will share our research into the object's provenance, with reference to the analysis of the materials and the manufacturing techniques employed. We also hope to have reached a conclusion as to whether the pair of table tops previously existed as a single square that was cut in half for an owner's convenience – the theory rests on their equal dimensions and symmetrical design. With this in mind we will describe our conservation strategi

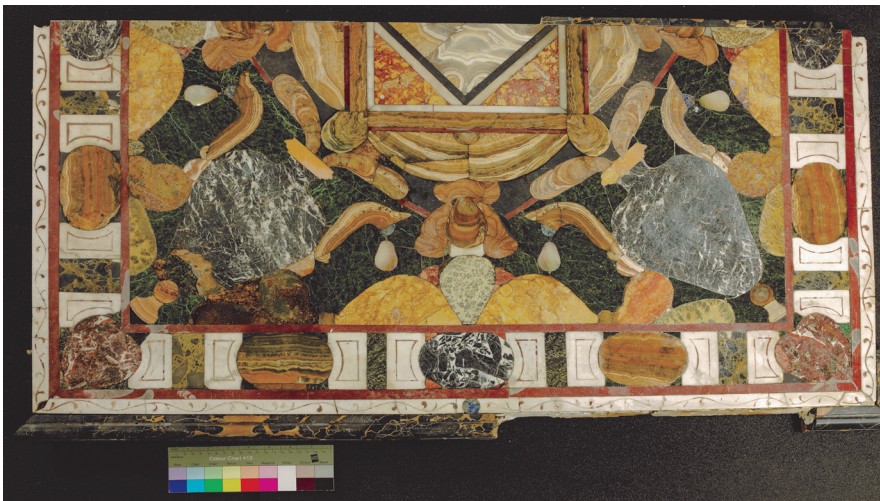
Fig. 1. The tabletop before treatment.

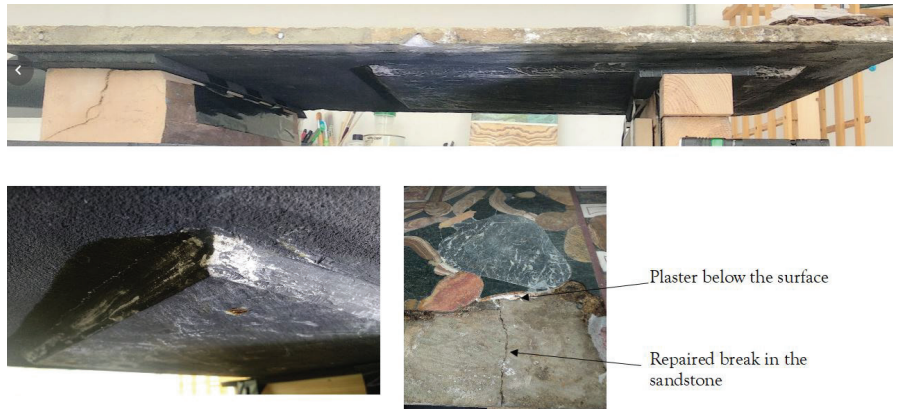
The table had clearly suffered serious impact damage but also displayed evidence of at least two previous restoration campaigns, for which no treatment records existed. About a third of the sandstone base slab (proper right hand side) had broken off, undoubtedly with the veneers above it, but had been later re-adhered and reinforced with a patch of stone that was screwed in from below (fig. 3).

Fig. 3. The patch repair on the underside of the table.

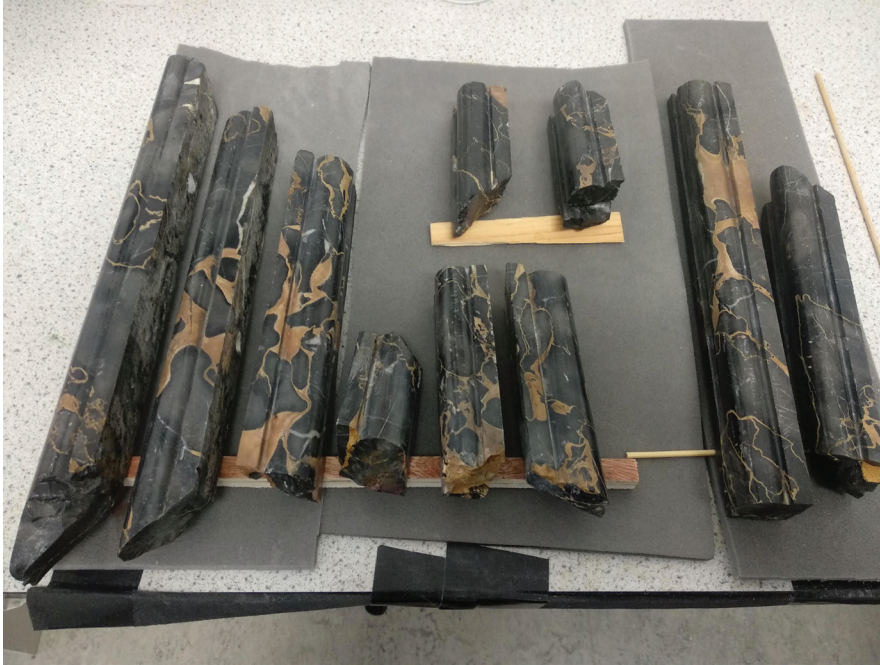
The Portoro Marble edge mouldings that once bordered the perimeter of the table had broken into several pieces. Some lengths remained loosely fixed to the table, others were delivered in a box of broken sections and shattered veneers, but a significant portion was missing altogether (fig. 4).

Fig. 4. Broken lengths of the Portoro Marble edge mouldings.

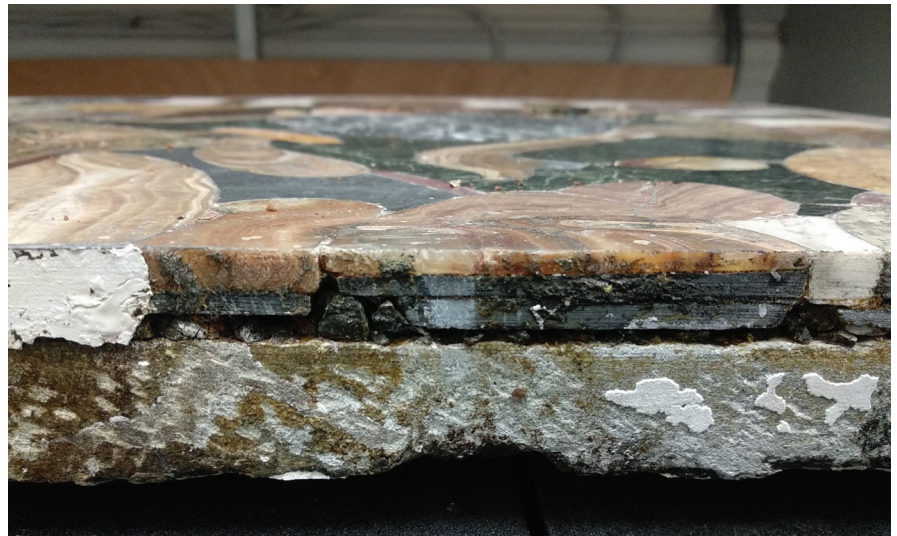
The losses to the mouldings provided a cross-section view of the tabletop which included the materials between the veneers and the base slab. The veneers varied in thickness, a construction method that was not uncommon for pietre dure surfaces; the depth of each veneer could be determined by the value and availability of different stone types (for example, it would reduce production costs if lapis lazuli veneers could be thinner than those of locally sourced white marble). To maintain a consistent height, thin veneers were backed with sheets of slate cut to the same shape; this would have provided support for fragile stones and also allowed for final adjustments; it is much easier to grind down slate to the correct height than hard stones¹ Elsewhere, roughly cut or shattered slate fragments were pushed in to further correct the height (fig. 5).

Fig. 5. Layer structure of the tabletop showing layers of slate between the veneers and the sandstone slab.

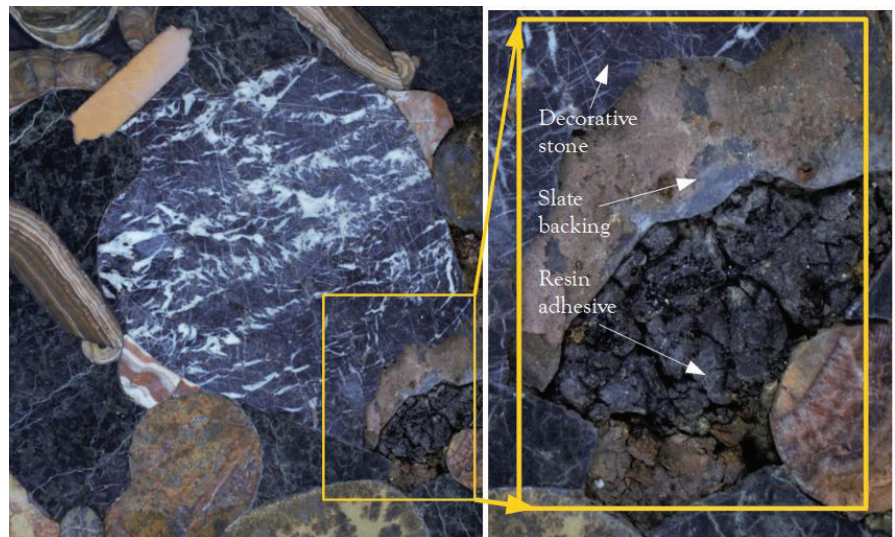
Probably due to the conditions of the conservatory, the natural tree resin gluing the veneers, slate layers and sandstone together had shrunken into hard crystallised crumbs and lost its adhesive properties. Colophony mixed with wax was a traditional glue for pietre dure veneers^{1, 2}. In this case, FTIR analysis confirmed the presence of natural tree resin, but not which type, although there were three different colours (orange, black and yellow), all exhibiting the same deterioration problems. A wax component was identified in samples taken of the yellow resin only. As a result of this deterioration, there was a lack of support underneath many of the veneers and the majority of them were only loosely attached (fig. 6).

Fig. 6. Deteriorated natural resin below the veneers

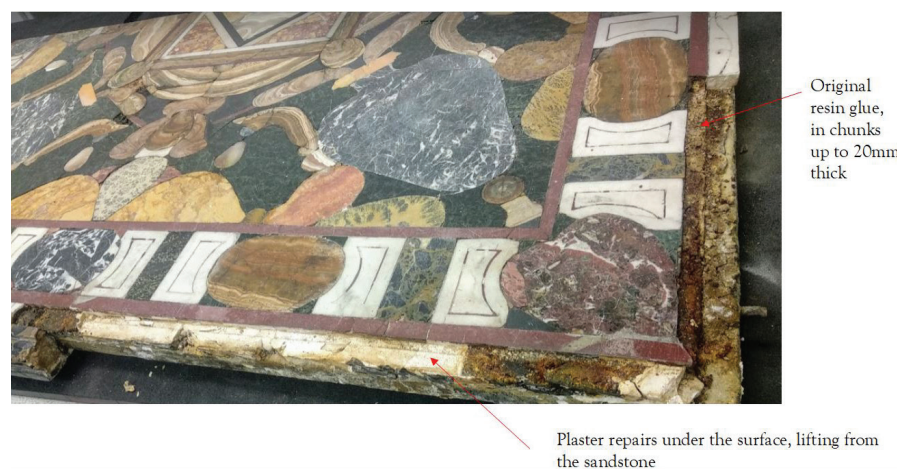
Fig. 7. Plaster repairs under the veneers at the proper right hand side.

During treatment (see section 4.1), it was discovered that the surface veneers on the proper right hand side above the sandstone repair been re-set by an earlier restorer with Plaster of Paris. The repair to the sandstone slab was stable, but the plaster used to reset the veneers was detaching from the substrate (fig. 7).

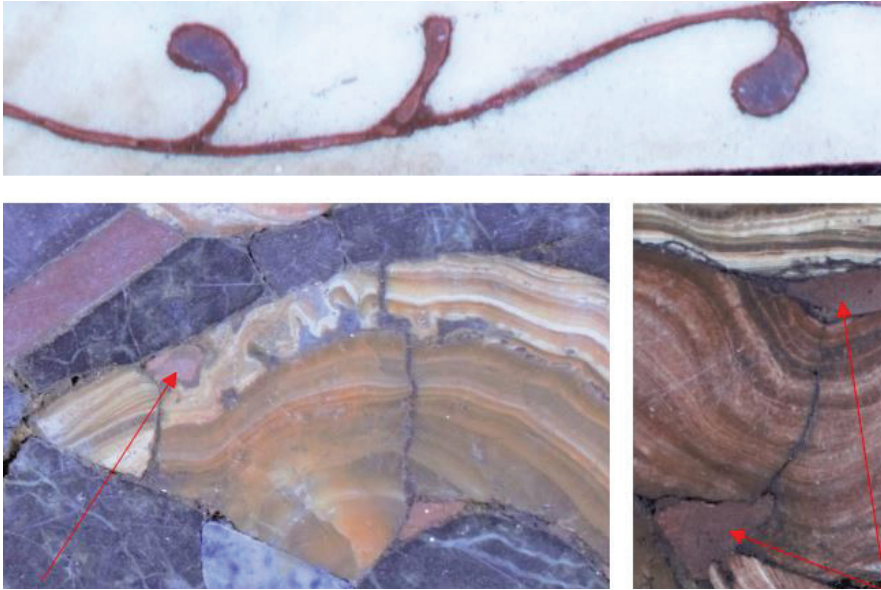
A mixture of original and non-original stone replacement materials were present on the surface. A red composite material containing red iron oxide and tree resin (analysed using polarised light microscopy (PLM) and Fourier Transform Infrared Spectroscopy (FTIR)), was thought to be original (fig. 8). Less successful fillers, such as rough lumps of stone or plaster, were thought to be more recent repairs (fig. 9).

Fig. 8. Red fill material composed of iron oxide particles and tree resin.

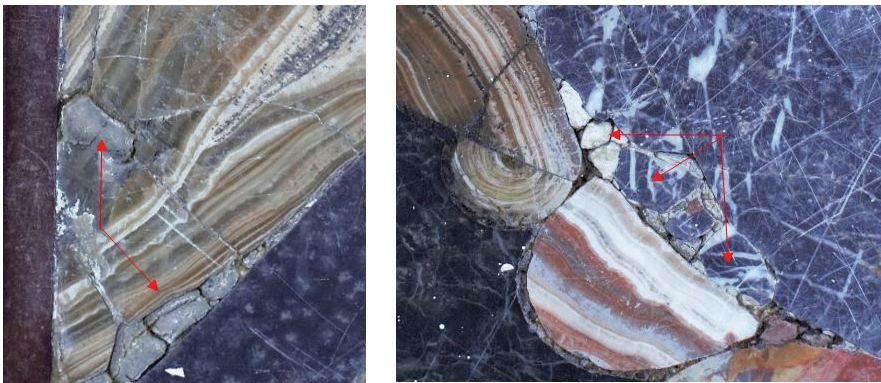
Fig. 9. Small unpolished stones and plaster used to fill losses

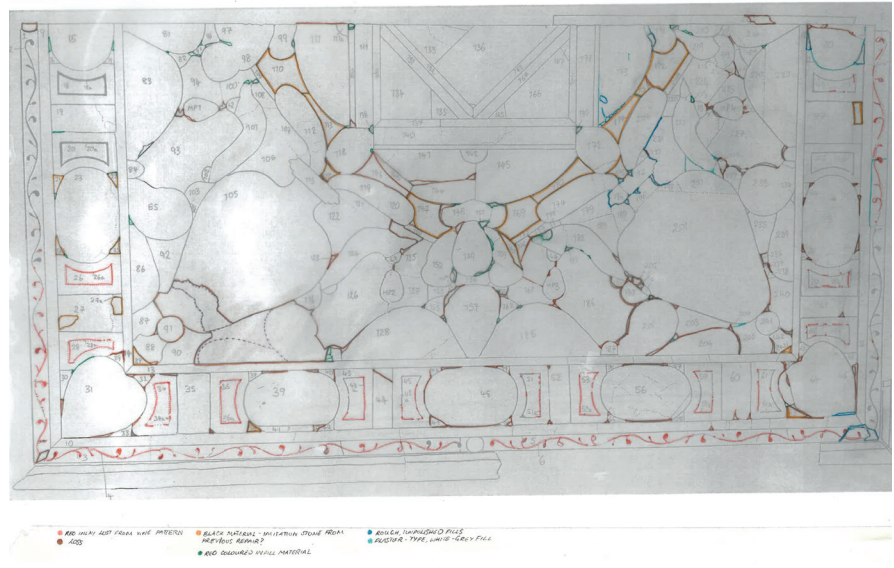
Fig. 10. Maps detailed losses, repairs, and areas in need of consolidation.

The condition of each decorative veneer was recorded carefully on annotated maps. Then, the attached moulding fragments and many of the veneers from the table were removed in order to access the ground layers for consolidation (fig. 10).

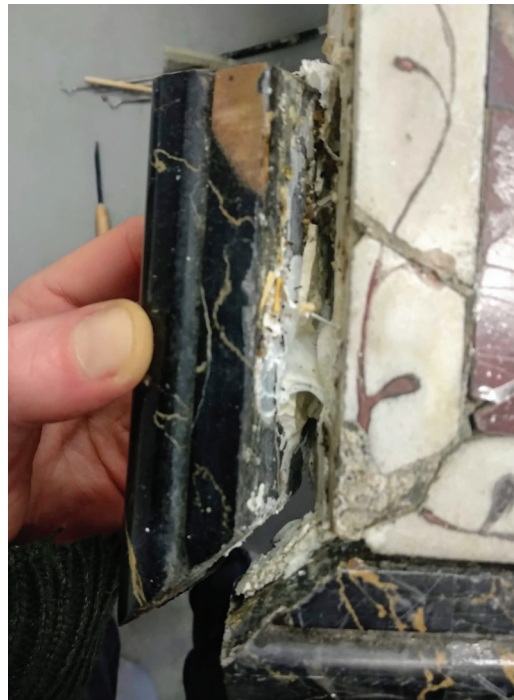
The moulding fragments were removed mechanically. It seemed that they were originally dowelled into place (a few dowels remained but all had caused significant wear and fracturing to the sandstone, so those still in place were loose), but that two different materials had subsequently been employed to re-adhere broken lengths; Plaster of Paris and silicone rubber were identified using FTIR analysis. This suggested two different restorations had been attempted in the same area (fig. 11).

Fig. 11. Removing misaligned mouldings

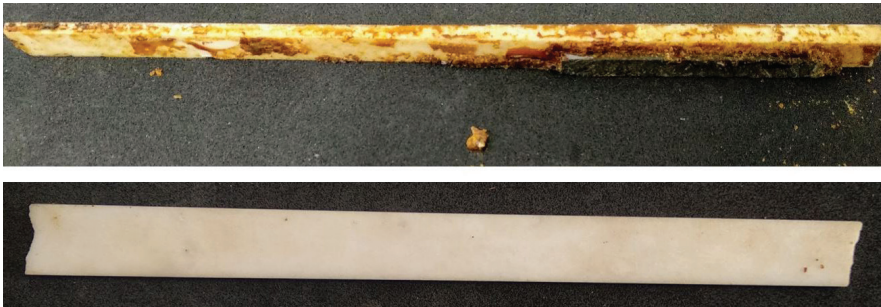
Fig. 12. A portion of the white marble border before and after cleaning.

The veneers were removed by picking out the old resin crystals underneath them, so they came away either whole or in pieces along old fracture lines. Fractured veneers were faced with Primal WS24 and Japanese tissue before removal and were subsequently cleared of resin with acetone on cotton swabs. Lumps of Plaster of Paris were stuck to the veneers near the repaired area; this was softened with an aqueous Laponite gel before being loosened with a scalpel. (fig. 12, a portion of the white marble border before and after cleaning). Broken veneers were repaired using Primal WS24, upside down on a sheet of glass to keep the surfaces flat, and backed with Japanese tissue paper for additional support. These pieces were stored on a scale drawing of the tabletop during the treatment of the lower layers (fig. 13).

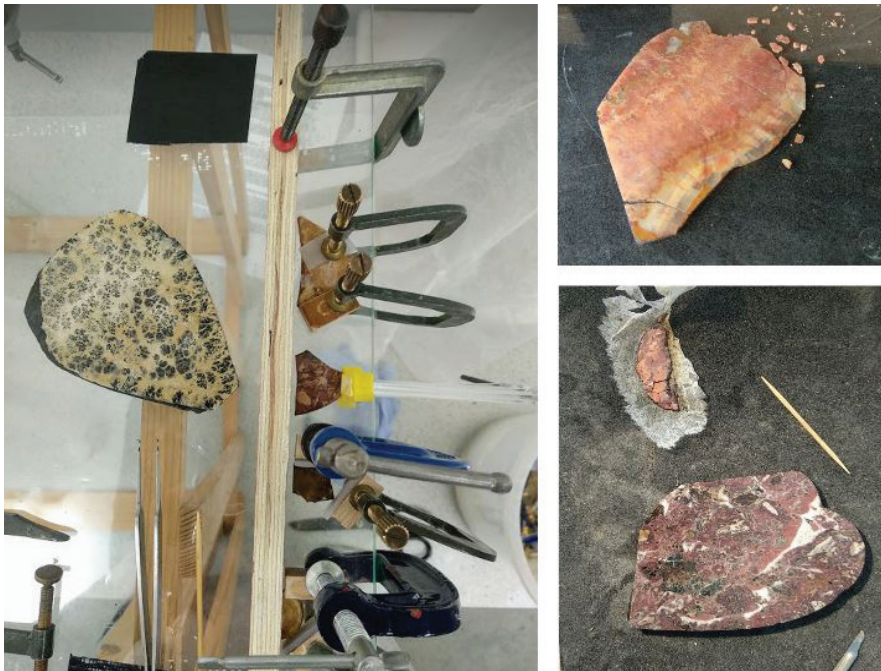
Fig. 13. Repairing veneers upside down on sheets of glass.

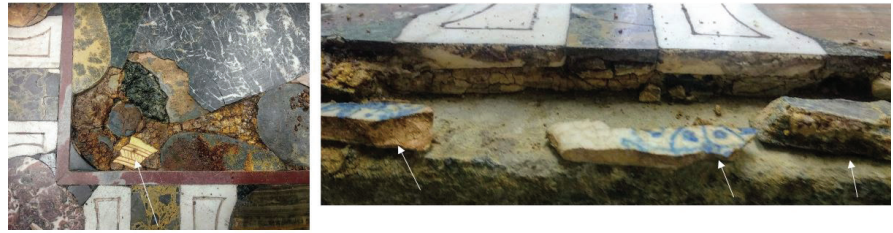
The ground layers resembled assorted rubble; broken sheets of slate, earthenware fragments with various glazes, broken ceramics, chunks of terracotta and small pieces of lead. These 'packing out' may have been original because they were set in resin rather than plaster or silicone. A lower quality of craftsmanship has been associated both with 18th century work made for export³ and poorer workshops in southern Italy, so these discoveries helped to support the tabletop's claim to these origins (fig. 14A and 14b).

Fig. 14a and 14b, rubble below the surface.

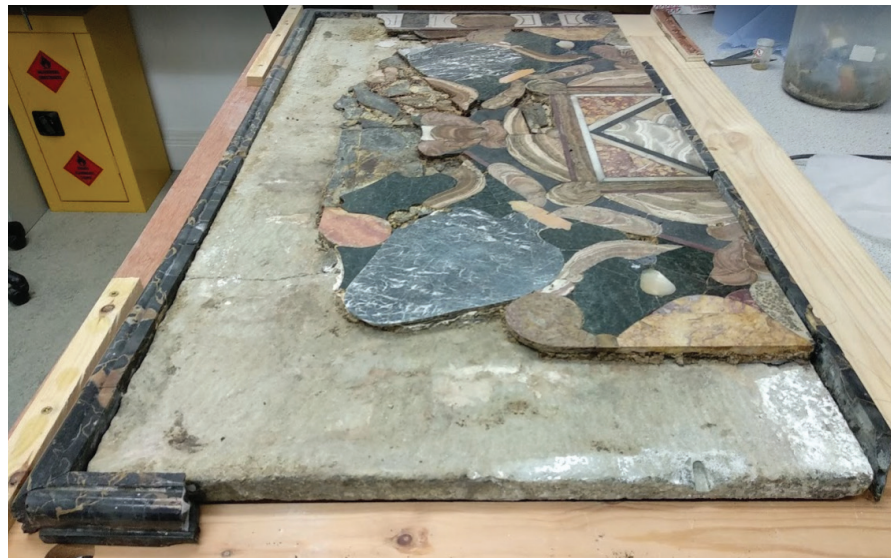
Approximately one third of the surface veneers and the ground layers below them were removed from the outer edges of the tabletop. The client found the degree of unevenness in the surface of the central area acceptable so no more stones were removed but, thanks to improved access, the ground layers could be consolidated (fig. 15).

Fig. 15. Showing the portion of stones removed before consolidation was possible.

Paraloid B67 was selected as a consolidant because it could be dissolved in white spirit, which did not react with the tree resin, whereas alcohols and ketones caused it to dissolve. Over two weeks, solutions were injected at concentrations increasing from 2% to 15% and finally bulked with microballoons, until the individual veneers seemed secure. Near the centre, new ground layers were built up using the bulked B67 and where possible, using the excavated fragments of slate and pottery, out of respect for the original scheme.

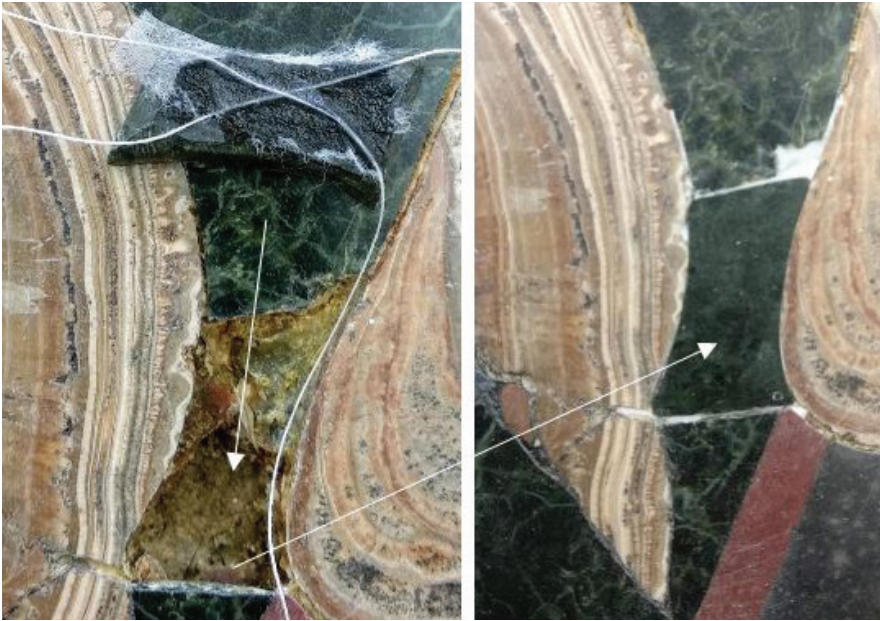
Fig. 16. Re-setting veneers.

A dry version of this mixture was built up until the relevant veneer could be placed on top of it and sit at the same height as the adjacent stones. The veneer was then removed and the bulked mixture allowed to cure, then a flowing solution of B67 was used to adhere the veneer in place. The adhesive was slow drying, which allowed for adjustments to be made for up to two days. Because most stones were worn at the edges, there were small gaps between them, which allowed for a useful technique; to keep the stones level, two crossed threads could be adhered to the reverse faces with Primal WS24 and Japanese paper, so the ends of the threads could be tweaked from all sides (fig. 16). It was more complicated to reset veneers that had previously broken into many pieces and this tended to take several hours of minor adjustments, using flat glass slides to push pieces to the correct height.

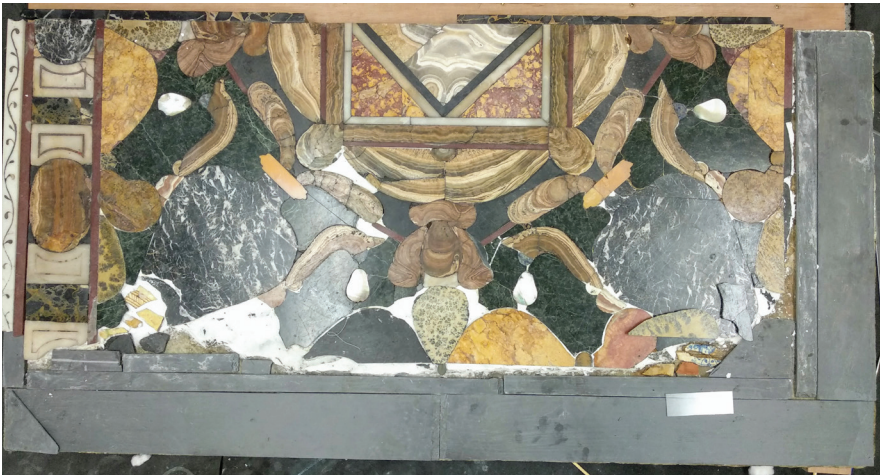
Fig. 17. New slate added to increase the height of the ground layers.

In addition, new slate sheets were used to help build up the height around the edges of the table in place of the deteriorated old material to increase stability and make resetting easier (fig. 17).

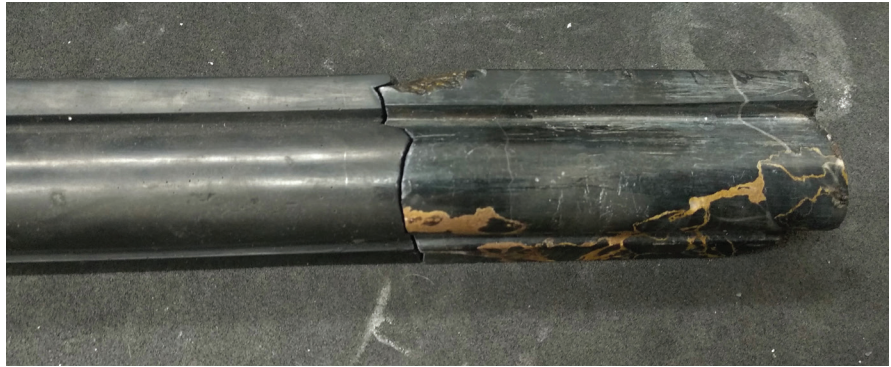
Fig. 18. Jesmonite cast before retouching, fitted to the original break surface.

Initially the plan was to make casts of the existing mouldings to replace the missing lengths. Several materials including epoxy and polyester resins and Jesmonite AC100 were tested and Jesmonite was selected as the best candidate. Jesmonite is an acrylic composite that is very strong, lightweight, water resistant, non-toxic and easy to colour match. It is prepared by mixing a dry powder and a liquid component which sets after approximately 10-12minutes, and pigments can be added to the mixture. The remaining fragment of the missing length was also cast, and that cast was inserted into the end of the mould so that the replacement section would have a corresponding break surface (fig. 18). However, just as the casts were finished a stone carving student at the university, Daniel Burbidge, offered to produce replacement lengths using real Portoro Marble, which was much preferred by the client, so the missing lengths were made again from stone and gaps were filled with pigmented Jesmonite. Nonetheless, Jesmonite was found to be an extremely useful alternative to stone and would be recommended for similar projects. Both existing and new moulding lengths were adhered to the sandstone using Paraloid B44 (30%) in acetone.

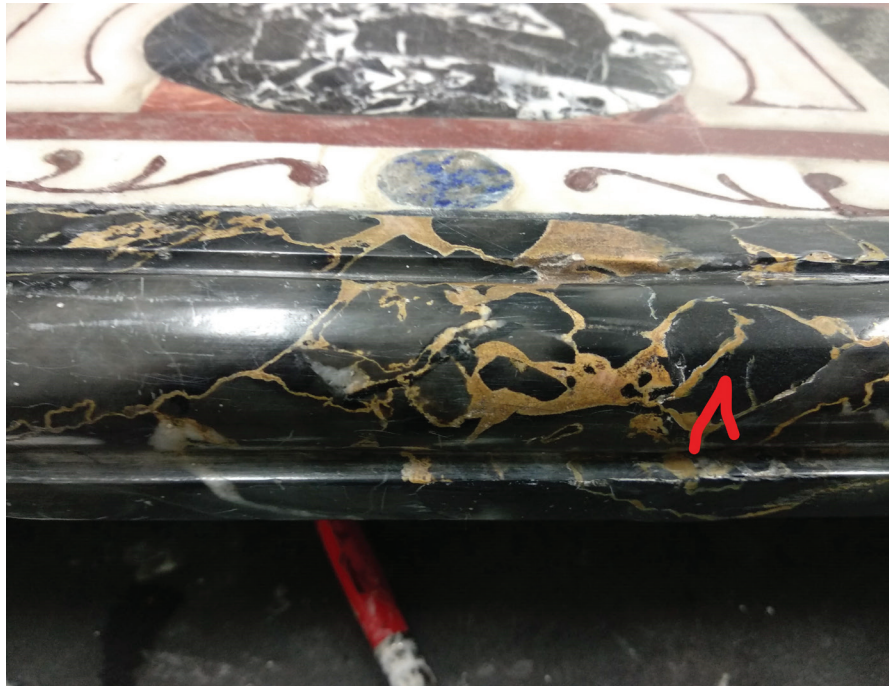
Fig. 19. Jesmonite fills

Losses to, and gaps between the veneers (previously filled with deteriorated resin) were filled with pigmented Jesmonite. Jesmonite is not traditionally used as a filler, but by preparing it in very small quantities it was found to be excellent for the purpose. Unlike most fillers, it expands slightly as it sets (by 0.15%, according to the manufacturer), rather than shrinking, which helped to lock the veneers in place. The fills could then be cut with tools, sanded, polished and reshaped or removed using acetone, without staining the stones (fig. 19). Minor retouching was subsequently carried out using Gamblin conservation colours.

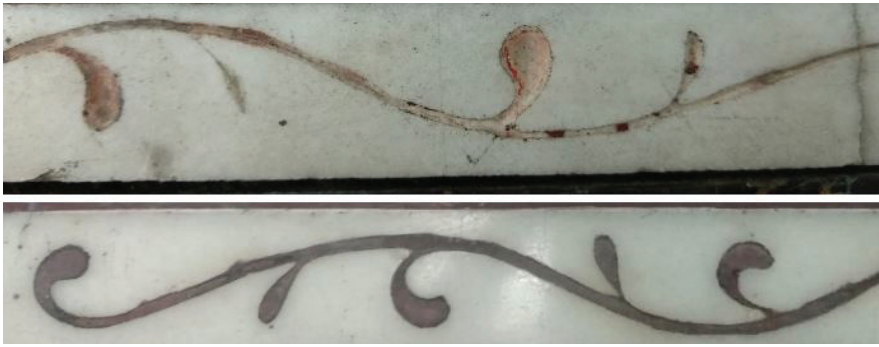
Much of the red fill material in the vine border was missing or crumbling away. Remaining passages were consolidated with sodium carboxy methyl cellulose at 2% in deionised water, which improved cohesion and caused no colour or gloss change. Areas of loss were coated with a barrier layer of Paraloid B67 (at 10% in white spirit) then filled with a bulked paint consisting of Aquazol 500 (2% in deionised water), kaolin powder, fine marble dust, dry pigments (red iron oxide, prussian blue and vine black). The pattern was first over-filled, then cut flat and level with the marble using a small, rounded cabinet scraper and polished with 4000x Micromesh. The result successfully matched the colour, fragmented appearance and condition of the original, whilst improving the legibility of the design (fig. 20).

Fig. 20. Before and after, border fills.

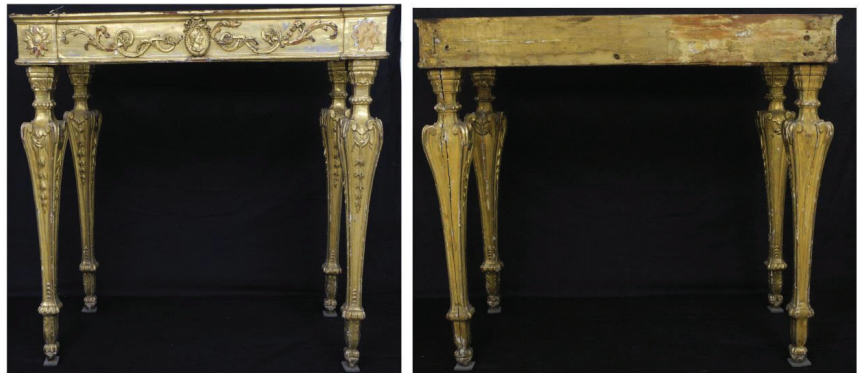
Fig. 22. The front and back of the giltwood base before treatment.

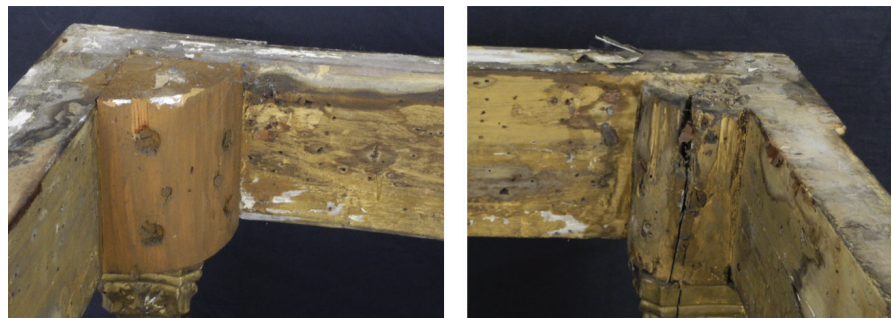
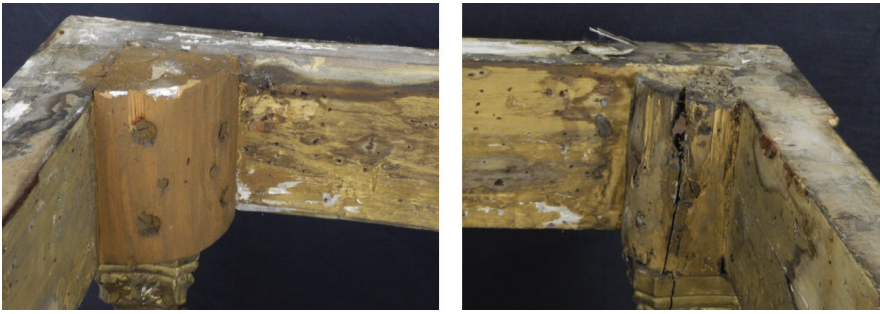
The upper part of the base was assembled by dovetail joinery, mechanically stabilising the structure, whilst inside corner blocks worked to the same end from the inside, amongst which was an historic repair (fig. 24, 24a, 24b).

Fig. 24a. Original internal structural support.

Fig. 24b. Later replacement of the internal structural support.

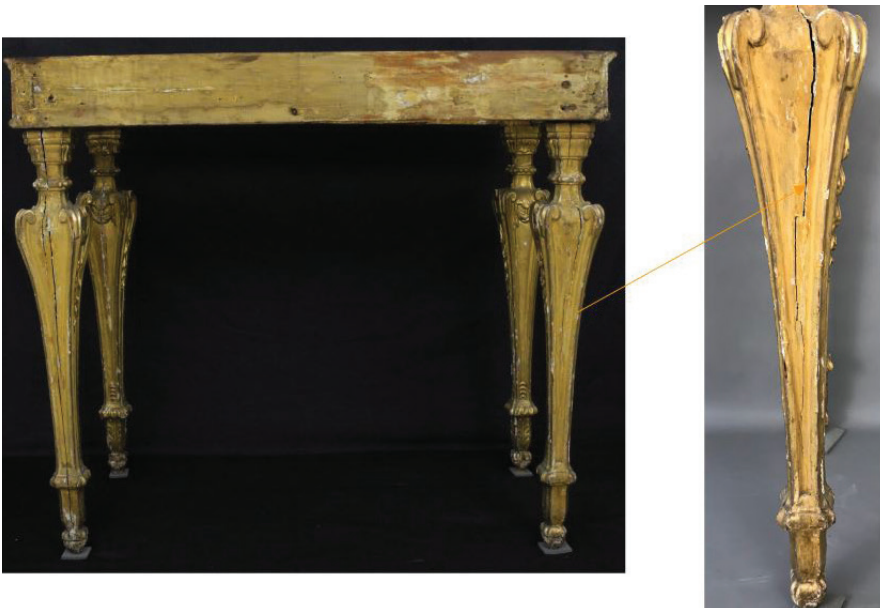
There were major splits on the back of each leg. It was first thought that these were caused by the weight of the tabletop but later examination showed that legs were made from single pieces of timber and that the cracks were naturally occurring radial splits. The splits did not compromise the table's stability but it was interesting to note that legs were deliberately positioned with the splits at the back to hide the defects. No other signs of stress-related cracking were present (fig. 25).

Fig. 25. An example of splits in the legs at the back of the table.

Following testing, it was concluded that Lascaux 360 (20% concentration) with microballoons and onyx powder was the most suitable for the purpose because it maintained some elasticity after ageing; this suggested that it would not limit natural expansion or shrinkage in the timber. This filling mixture was applied over a barrier layer of Japanese tissue paper, (fig. 37 and fig. 38).

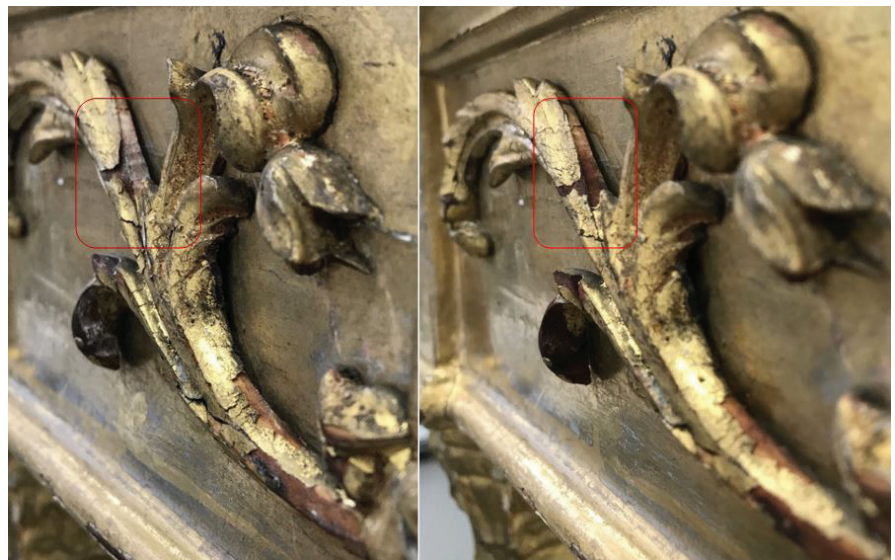
Again, due to the fluctuating environmental conditions in the conservatory the decoration was badly damaged. There were losses to the carved ornament and some parts were detached. There were also losses to the gilding, which exhibited craquelure and lifting gold flakes and evidence of overpaint in some areas – possibly bronze paint.

Fig. 31. Before and after consolidation of the gilding.

Consolidation and cleaning were carried out using traditional methods. The flaking gold was consolidated first, as it was particularly unstable, using rabbit skin glue in deionised water (1:12), to which the surface responded very well (fig. 31). Subsequently the surface was cleaned using a minimal amount of water with a very low concentration of rabbit skin glue, and saliva in areas of stubborn dirt. The overpaint was removed with benzyl alcohol, applied by brush and rinsed with a swab after 3-4 minutes.

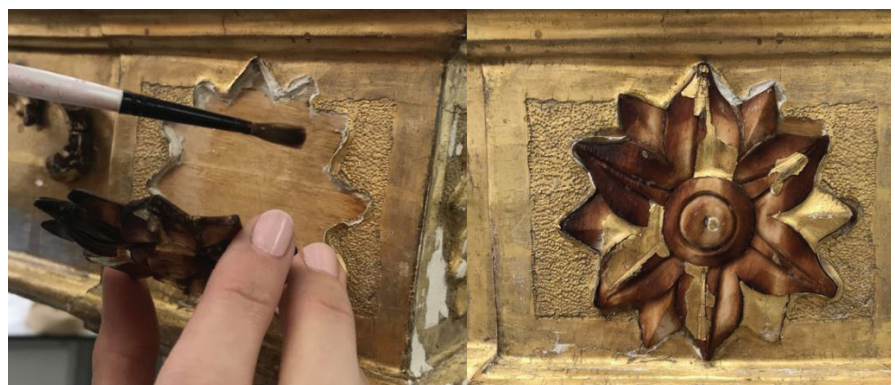
Fig. 32. Re-gluing the original ornament with hide glue.

The detached ornaments were re-glued with hide glue in deionised water (1:3), in keeping with the original assembly methods (fig. 32). The missing sections were carved out of new lime wood, using the existing ornaments as a reference, and were also glued with hide glue (fig. 33).

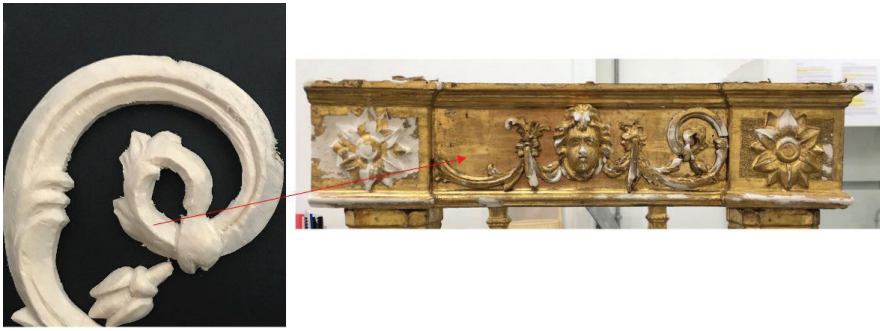
Fig. 33. Re-carving missing ornament.

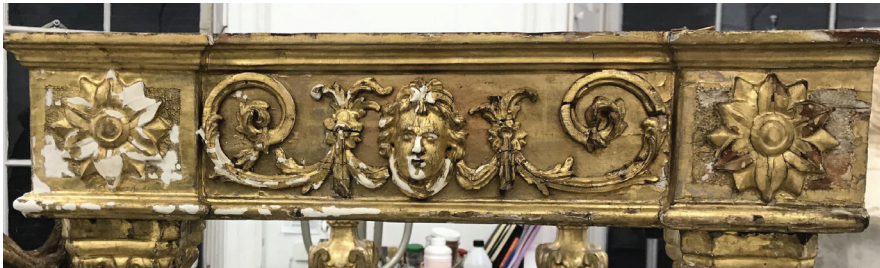
Fig. 34. Surface losses being filled with gesso putty.

Surface losses were filled with whiting and rabbit skin glue (gesso putty) in order to stabilise the surrounding areas and to improve the overall appearance (fig. 34). Larger areas of loss were painted with bole and water gilded, but smaller areas were retouched using the Italian technique known as 'tratteggio', meaning 'hatching'. Tratteggio entails applying very thin, closely spaced parallel lines to an area of loss using only pure primary colours (yellow, red and green); the effect is not noticeable from a distance but can be readily distinguished from the original on close inspection. Evidence of earlier tratteggio retouching was identified on the table legs (fig. 35 and fig. 36 a/b).

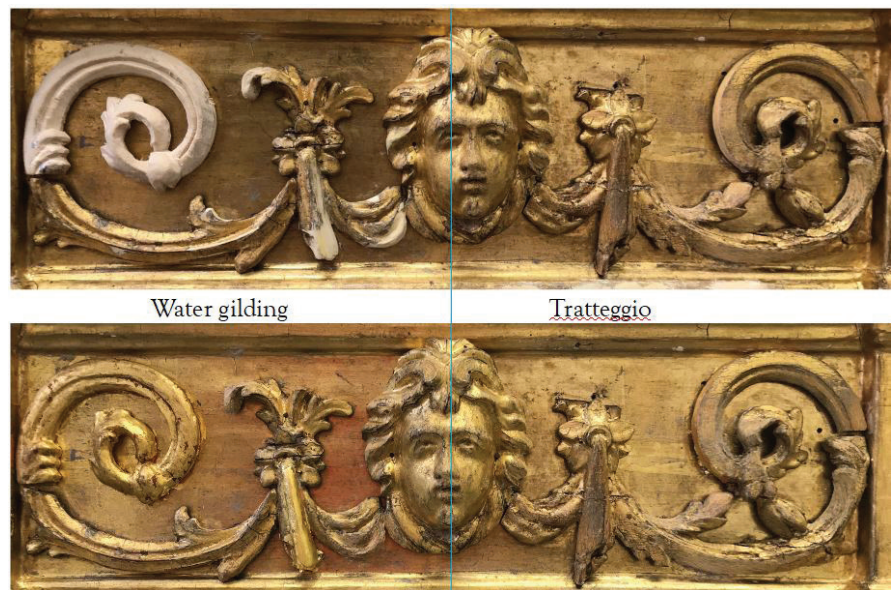
Fig. 35. Water gilding and tratteggio.

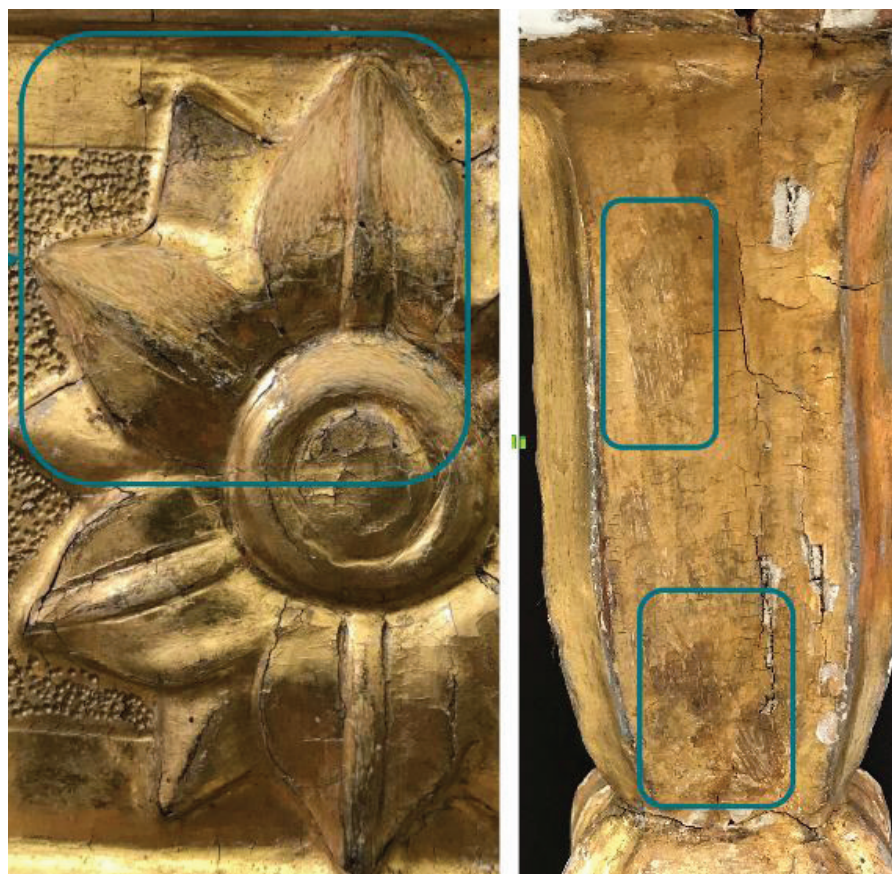
Fig. 36. a) new tratteggio b) earlier retouching using the same technique on the legs.
