Presented at Icon Heritage Science Group's event: 'Historic document analysis using p-XRF: Pitfalls and Possibilities', 11th September 2017, The National Archives, UK.

The Board of Trade design registers ...

The National Archives' Collection Care department was enlisted to identify whether arsenic was present in any of 279 selected designs. The results were to feature in a book, 'Bitten by Witch Fever' by Lucinda Hawksely (Thames & Hudson Ltd, 2016), supporting written historical evidence that arsenic-containing pigments were used in wall hangings of this time.

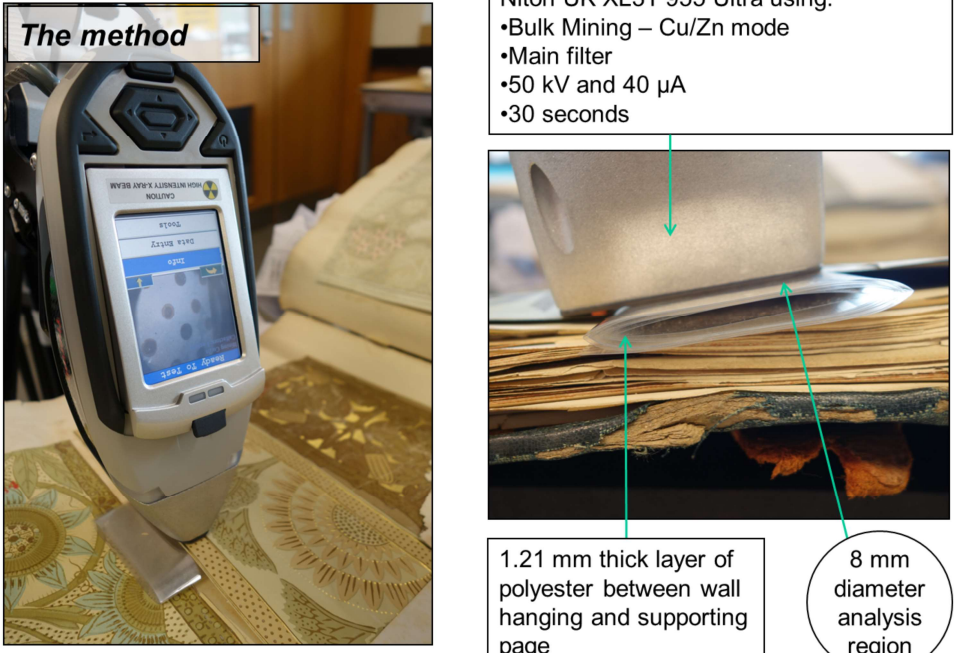
Niton UK XL3T 955 Ultra using:

- Bulk Mining – Cu/Zn mode
- Main filter
- 50 kV and 40 μ A
- 30 seconds

1.21 mm thick layer of polyester between wall hanging and supporting page

8 mm diameter analysis region

Non-destructive analysis to determine the arsenic content in the yellow and/or green-based pigments in BT43/103 designs was undertaken using a Niton UK XL3T 955 Ultra handheld X-ray Fluorescence Analyser (XRF analyser). A 1.21 mm thick layer of polyester was placed between the region of interest in a design and the supporting page in the volume. A maximum of two colours were analysed per design. Selected supporting papers were also analysed. The analyser measures an 8 mm (diameter) area using an X-ray tube with a gold target and a Peltier cooled detector. Operating conditions were 50 kV and 40 μ A for 30 s using the main filter on 'Bulk - Mining - Cu/Zn' mode. The % arsenic content as well as details such as the colour, location, and description of the area of analysis was recorded in a spreadsheet during analysis.

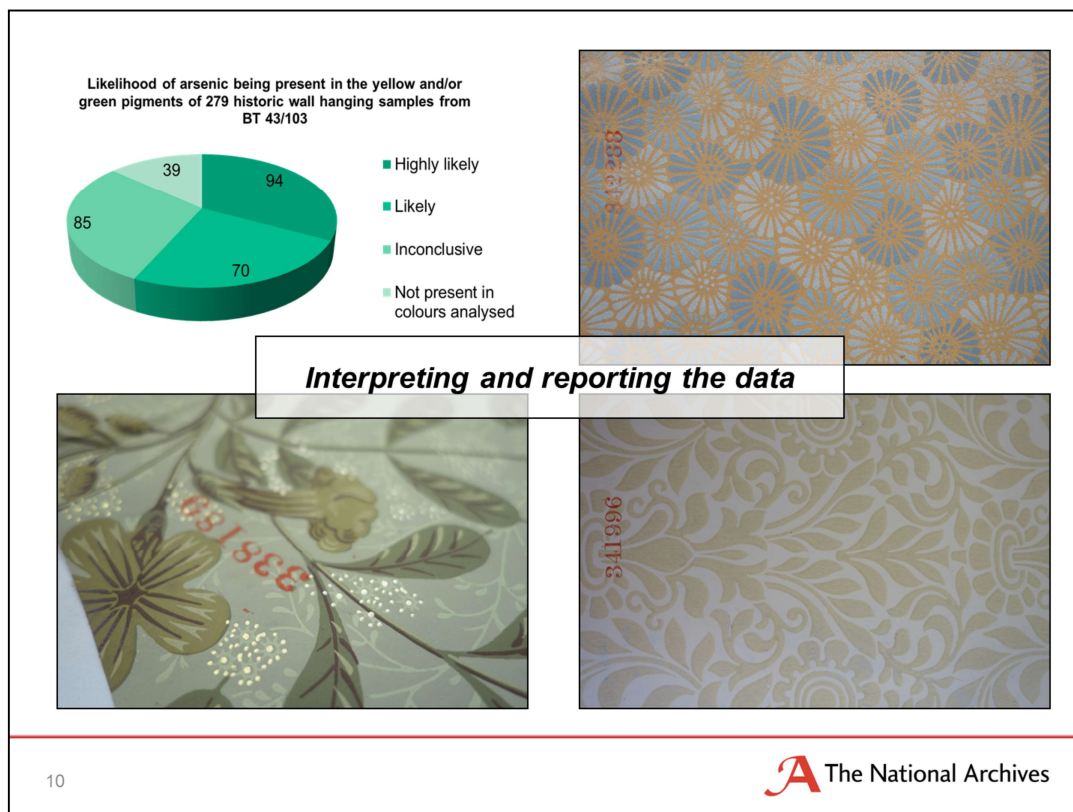
highly likely (0.1% or greater reported arsenic content) e.g lower LHS image, likely (0.05 – 0.1% reported arsenic content), inconclusive (up to 0.05% reported arsenic content), not present e.g. RHS images.

Due to the semi-quantitative nature of the results, we chose to not share the % arsenic values with the author and publishers. In particular because despite warnings about the semi-quantitative nature of the results, discussions suggested that there was a strong possibility that they would take the data literally, inadvisably publishing and comparing % arsenic contents of different wall hangings. Instead we provided a report in which the likelihood of the wall hangings containing arsenic was indicated. This we did using the following scale:

The boundaries to these categories are based on assumptions related to the level of error in the results that I anticipated could arise due to the presence of arsenic in samples below that of interest. These boundaries could change with more in-depth research. In such cases it is likely that some of the 'inconclusive' results would be re-categorised as 'likely'.
