Concrete Thinking: How a Study of American and British Remounting Methods Informed the Treatment of Two Delft Tile Fireplaces at Winterthur Museum

ABSTRACT

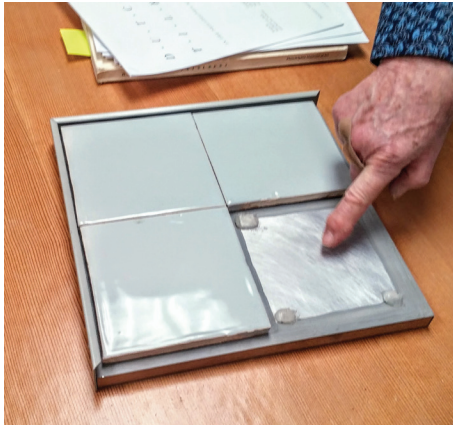
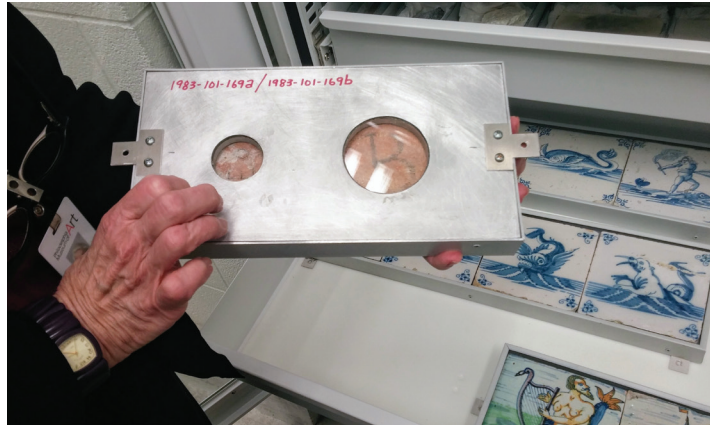
Figure 1. Conservator Melissa Meighan displaying a didactic of how the tile panels are constructed (left), and Curator Emeritus Mary Anne Dutt Justice showing the verso of a panel with plexiglass windows to allow viewers to see inscriptions on the tiles' versos (right). Tile panel featuring a dolphin, ca. 1600-1625 CE, H 14.3 cm × W 27.9 cm. Philadelphia Museum of Art, 1983-101-169a and 1983-101-169b · Courtesy of Philadelphia Museum of Art

At the beginning of the PMA remounting process, curators arranged tiles with similar designs into sets for mounting in panels. Next, a barrier layer of PARALOID B-72 was applied in square sections to four corners on the verso of each tile, over which the silicone adhesive was applied. The viscosity

of the silicone adhesive allowed for leveling of the tiles, which are often of different thicknesses. If any inscription was visible on the reverse of the tiles, a plexiglass window was placed into a void in the Hexlite board. Meighan has had to dismantle a panel and stated that the mounting system is readily reversed by applying acetone to the PARALOID B-72 barrier layer (personal communication, 7 February 2017) (Figure 1).

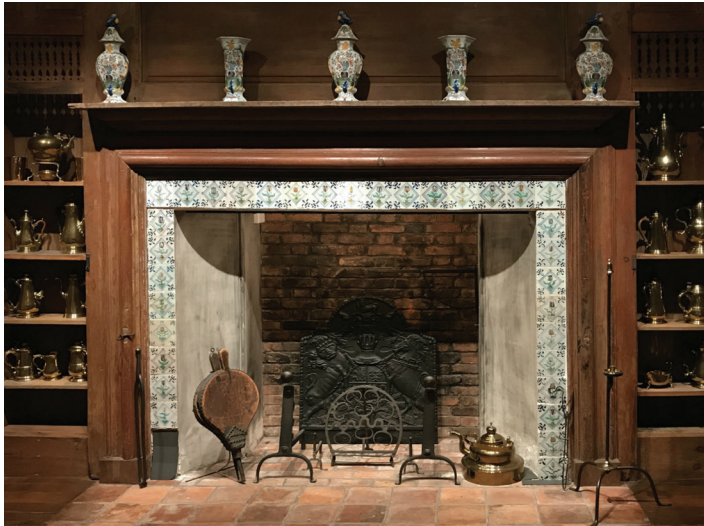
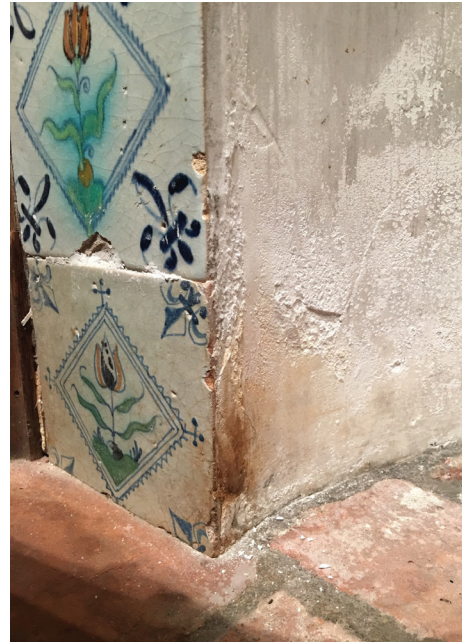
Figure 2. Vauxhall Fireplace (left) and detail of salt damage on the tiles and plaster surrounds (right), Winterthur Museum, 1969.4722.002 - 1969.4722.036 (clockwise from the lower proper right) · Courtesy of Winterthur Museum, Garden & Library

Vauxhall's tiles and plaster surrounds sustained heavy water damage from a flood in the summer of 1987. Soluble sulfate salts were confirmed through microchemical spot testing of small samples of white accretions on the tiles' surfaces (Odegaard, Carroll, and Zimmt 2007, 124-125). This makes sense, as the tiles are set directly into gypsum plaster; the lower part of the plaster surround was also delaminating due to the previous water damage (Figure 2).

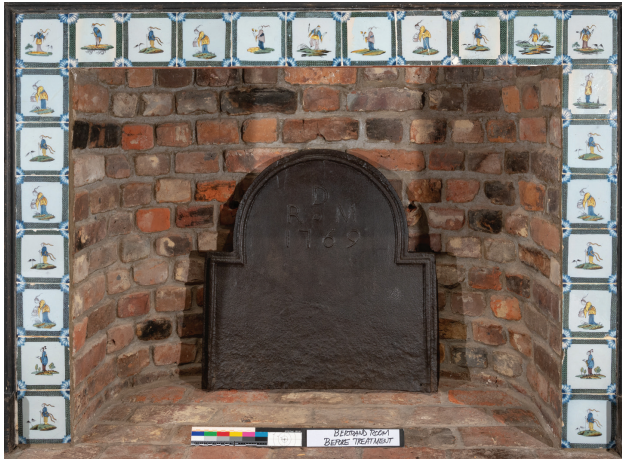
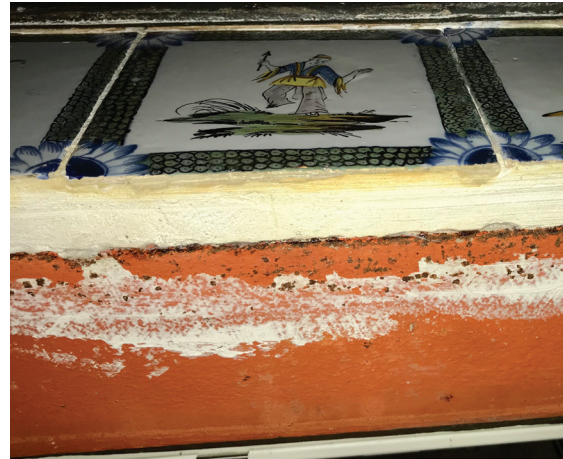
Figure 3. Bertrand Fireplace (left) and detail of plaster and steel armature (right), Winterthur Museum, 1969.4720.002 - 1969.4720.026 (clockwise from lower proper right) · Courtesy of Winterthur Museum, Garden & Library

The 25 London delft Chinoiserie tiles, ca. 1760-1775, in the Bertrand Room fireplace were installed between 1929 and 1930. Winterthur mason Benjamin Terranova (personal communication, 07 January 2017) posited that builders constructed a steel frame to create the fireplace façade and attached tiles with Portland cement on the side columns. The top row of tiles were installed differently, set in gypsum plaster. Both the plaster and the imbedded tiles cracked, possibly because the rigid cement side columns

and steel armature did not move with the building as it settled. Though the tiles were still attached to the plaster, the entire row was at risk of falling out, swinging freely away from the steel substrate with gentle pressure (Figure 3). In addition to the structural instability, previous aesthetic loss compensation and overpainting had aged poorly.
