Harriet Lewars & Jonida Mecani

Conserving a pietre dure table

This joint paper will present the ongoing conservation of an eighteenth century Italian pietre dure table. The table top and base are being treated separately by the two authors. The object, privately owned, is one of two matching rectangular pier tables which had deteriorated after thirty years of being kept in a household conservatory. Unfortunately the unstable environment had actuated some difficult conservation problems; for the base this included structural splits, instability and surface losses, whilst for the table top, a total cohesive failure between individual decorative stones and ground layers, further complicated by extensive losses, fracturing and previous restorations. We will share our research into the object's provenance, with reference to the analysis of the materials and the manufacturing techniques employed. We also hope to have reached a conclusion as to whether the pair of table tops previously existed as a single square that was cut in half for an owner's convenience – the theory rests on their equal dimensions and symmetrical design. With this in mind we will describe our conservation strategi

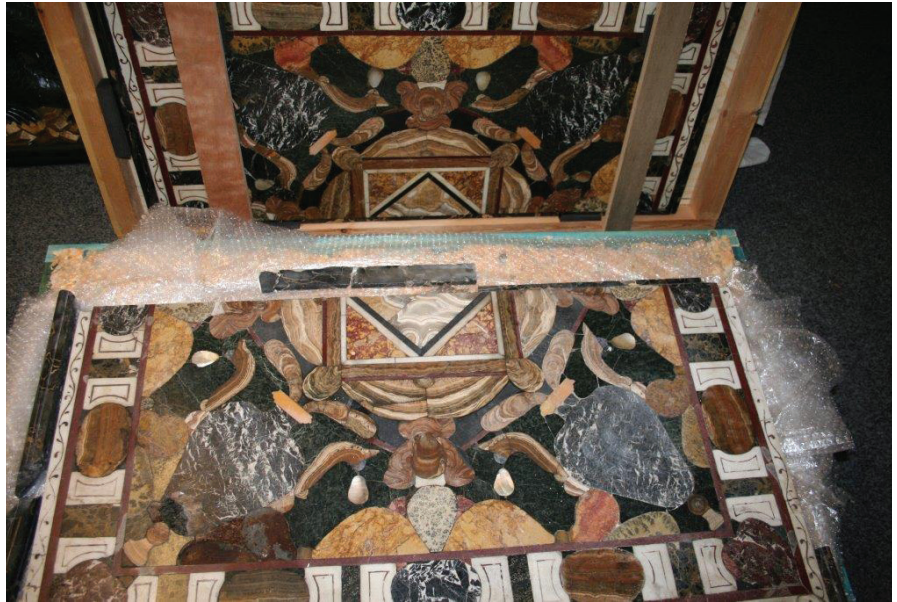
An 18th century, southern Italian origin was proposed, based on the style and features it had in common with examples of known origin such as mother of pearl inlay and the use of composite materials in detailed areas. One of a pair (the partner table was scheduled for treatment at later date), the symmetry of design between the two suggested that the tops may previously have existed as a single square that was later halved to produce two smaller rectangular tables (fig. 2).

Fig. 2. The tabletops together in storage.

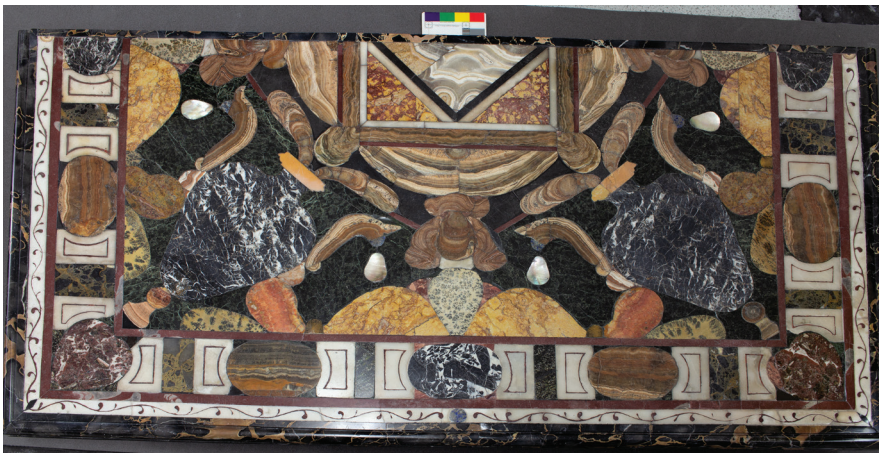
Fig. 21. Tabletop after treatment.

A wax paste made from a mixture of Renaissance wax (33%), carnauba wax (17%) and white spirit (50%) was applied as a protective coating against liquid spillages, dirt, stains and further scratching, to saturate the colours of the stones and to establish a shine similar to that on the partner table, which had also been waxed. The paste was prepared by melting the waxes in a bain marie, adding the solvent off the heat and allowing to cool. It was applied with a soft bristle brush and buffed the following day with a soft cloth.

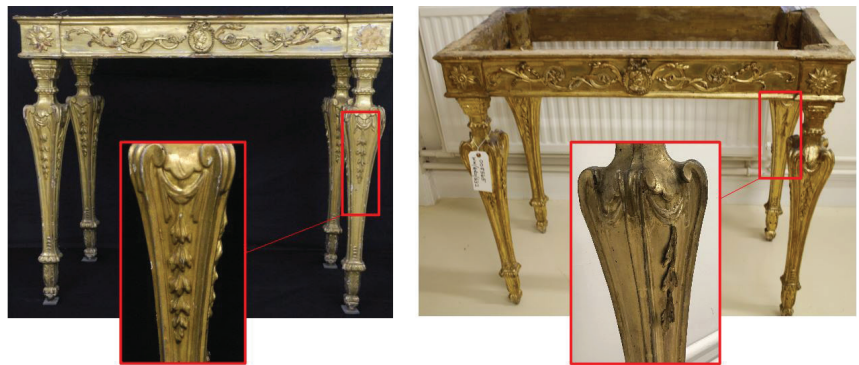
It was interesting to compare the giltwood base with that of the partner table; they presented the same decorative scheme but were constructed differently. For instance, our table had ornaments carved into the timber while on the partner table the ornaments were carved separately and affixed to the leg (fig. 23).

Fig. 23. Left: the base with ornaments carved into the leg; right: applied ornaments on the partner table.

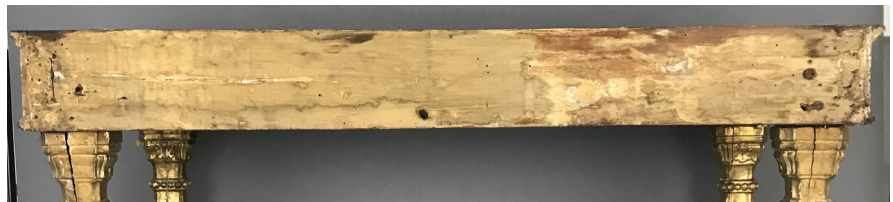
The upper part of the base was assembled by dovetail joinery, mechanically stabilising the structure, whilst inside corner blocks worked to the same end from the inside, amongst which was an historic repair (fig. 24, 24a, 24b).

Fig. 24. Dovetail joinery in the exterior timber.

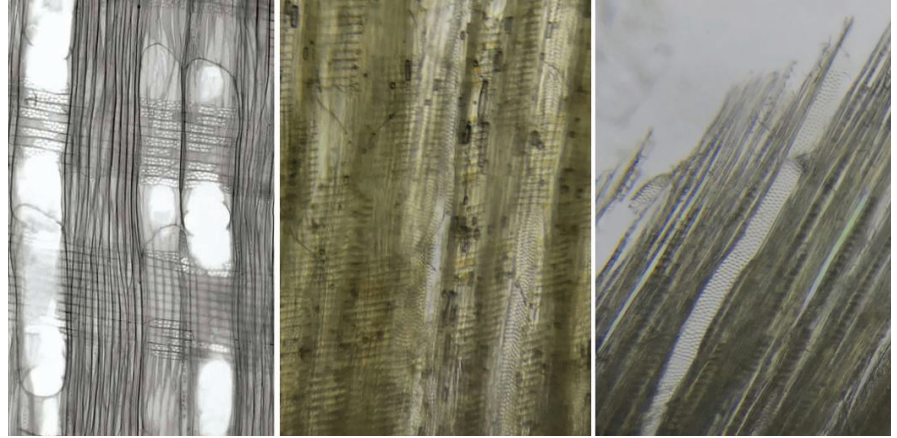
The wood was identified as Poplar *Populus Italia*, which helped point to an Italian provenance. (fig. 26)

Fig. 26. Thin section samples taken to identify the wood.

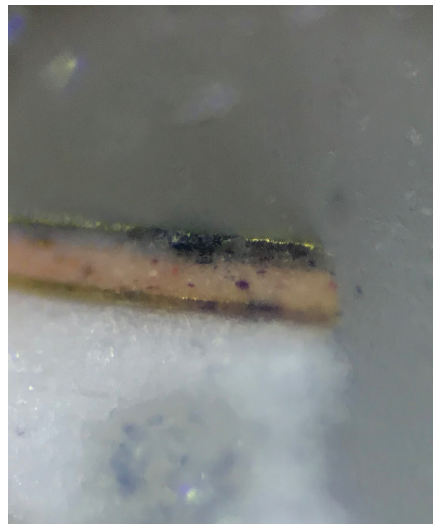
Three applications of bole were identified on the legs, the first red, the second a paler red and the third grey. (Fig. 27a, sample from the front leg, 200x magnification. 1 - gesso, 2 - red bole, 3 - gold leaf, 4 - pale red bole, 5 - gold leaf, 6 - grey bole, 7 - gold leaf, fig. 27b).

Fig. 27a. Sample from the front leg, 200x magnification. 1-gesso, 2-red bole, 3-gold leaf, 4-pale red bole, 5-gold leaf, 6-grey bole, 7-gold leaf.

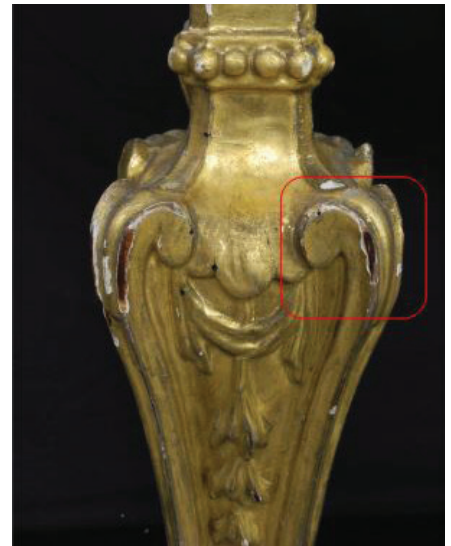
Fig. 27b. Sample location on the leg

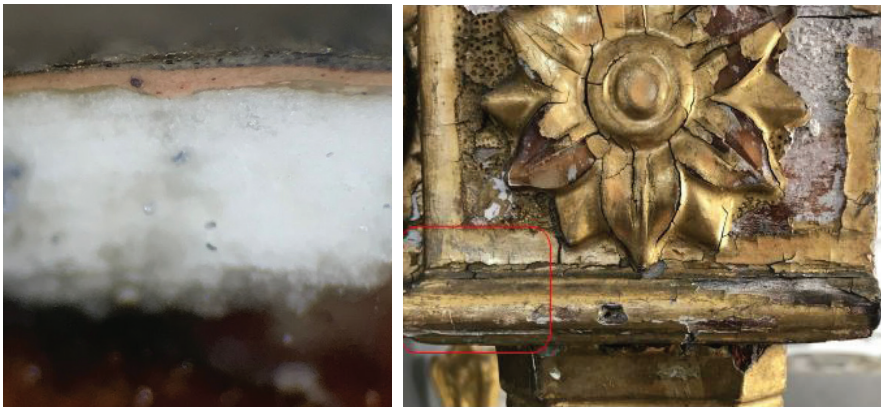
On the frieze, there were only two applications of bole (first pale red, then grey) and on the applied ornament only a single layer of red bole was visible. The colour of the red bole further supported a possible Italian provenance. (fig. 28a, sample from the frieze, 200x magnification - layers from ground to surface - 1- gesso, 2, pale red bole, 3, gold leaf, 4, grey bole, 5, gold leaf, fig. 28b).

Fig. 28a. Sample from the frieze, 200x magnification- Fig. 28b. Sample location on the frieze.
 tion-layers from the ground to surface. 1-gesso, 2- pale red bole, 3-gold leaf, 4-grey bole, 5-gold leaf.

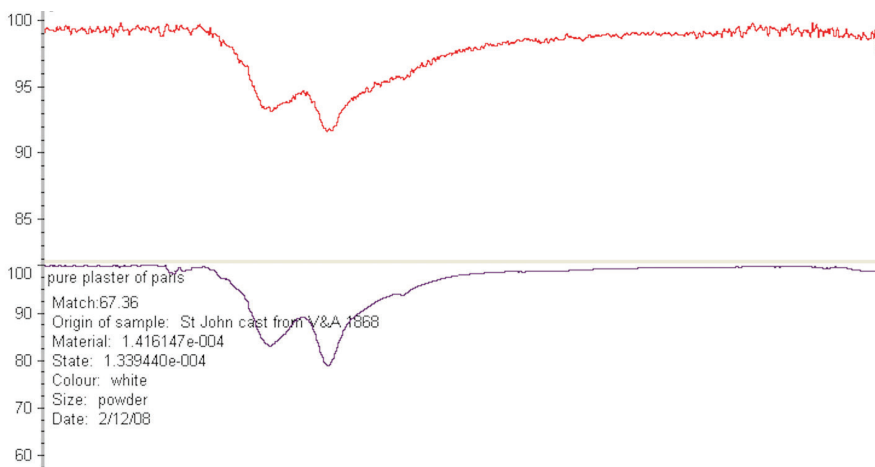
FTIR analysis showed that the materials used in the ground layers of the legs included Plaster of Paris (calcium sulfate), which differed from the upper part of the table where calcium carbonate was identified in the ground layers. This suggested that the legs were attached later and possibly that the table's components were assembled from other pieces of furniture to accommodate the pietre dure tabletop. Plaster of Paris was widely used in gilding preparation layers in Italy, whereas in England, whiting (chalk) was more commonly used. These findings suggested that the legs were made in Italy but were attached to the top part of the table and re-gilded at a later date, possibly in England. Fig. 29, top spectrum shows the ground layer on the legs, matching with a reference sample of Plaster of Paris (calcium sulfate) Fig. 30, top spectrum shows the ground layer on the frieze matching a reference sample for calcium carbonate. (whiting)

Fig. 29. Top spectrum of the ground layer on the legs.

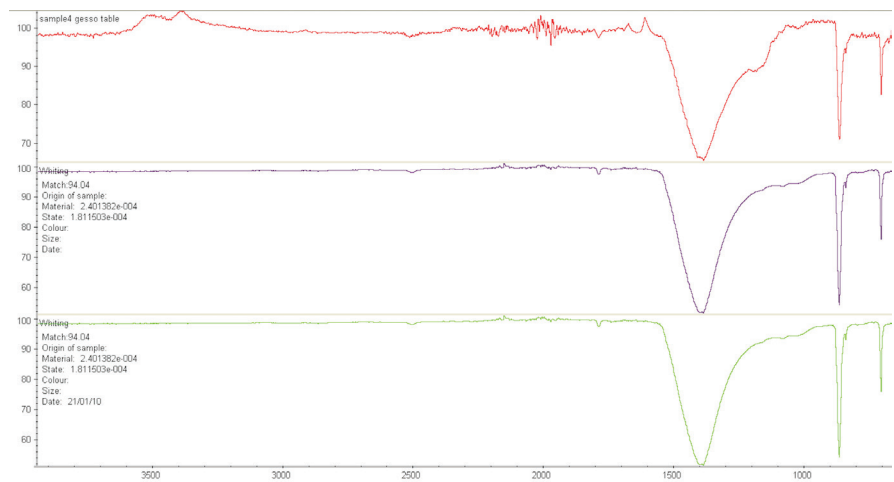
Fig. 30. Top spectrum of the ground layer on the frieze.

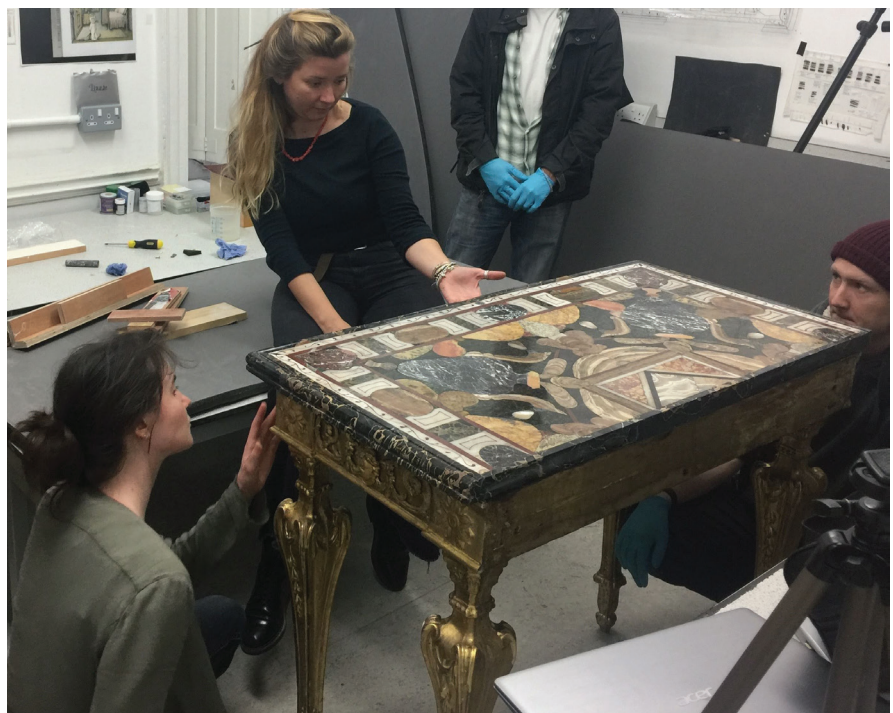
The aims – to stabilise the tabletop and base sufficiently for domestic use, to re-set all detached elements, replace missing parts and to obtain an appearance comparable to that of the partner table – were successfully achieved on time. The repairs carried out were often visually discernible but discreet, so the object could serve its function as a display piece in a domestic environment.

Fig. 40. The tabletop and base reunited after treatment.

The objects were returned to their owner with documents recording the treatment in detail and giving care recommendations for display, storage and maintenance (fig. 40).
